# Manhole Inspection Summary

Manhole # S17K\_\_043MH

Insp Date: **4/8/08 9:17 AM**

**Location** Address: **2514 emerson-pratt alley**

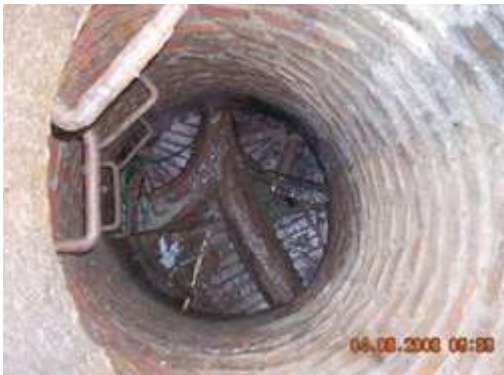
misc

bench & channel debris

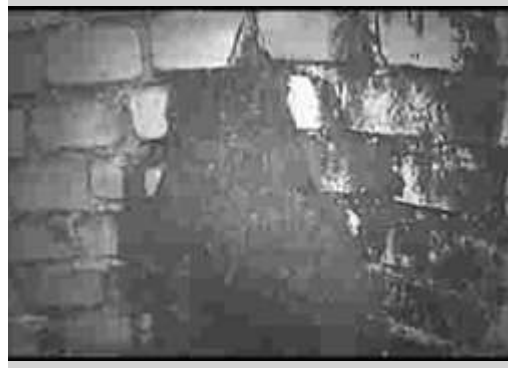
Defect 3

Infiltration: ☐ None ☐ Joint ☐ Cracks ☐ Mortar ☐ Roots ☒ **Wall**

infiltration @ barrel wall

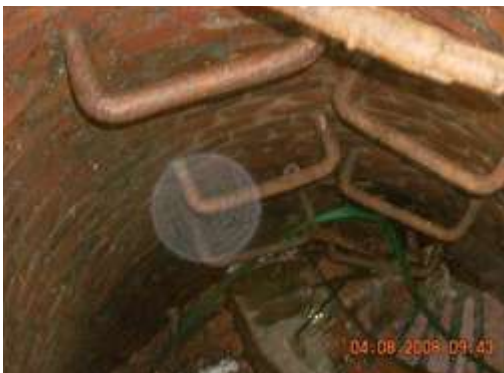
Defect 2

Count: **7** Missing: **0** ☒ **Corroded**

corroded steps

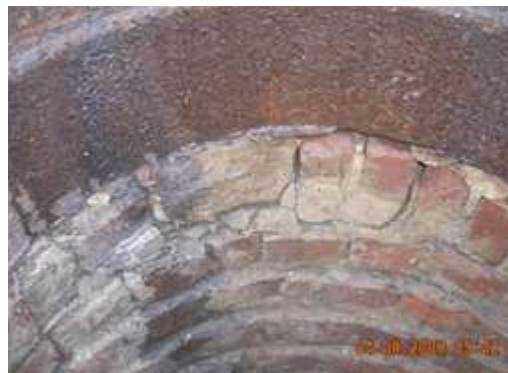
Defect 1

Condition: ☐ Sound ☒ **Cracked** ☐ Root Intrusion ☐ Loose Brick ☐ Deteriorated

Infiltration: ☐ None ☐ Joint ☐ Cracks ☐ Mortar ☐ Roots ☒ **Wall**

cracked chimney bricks, infiltration @ corbel wall

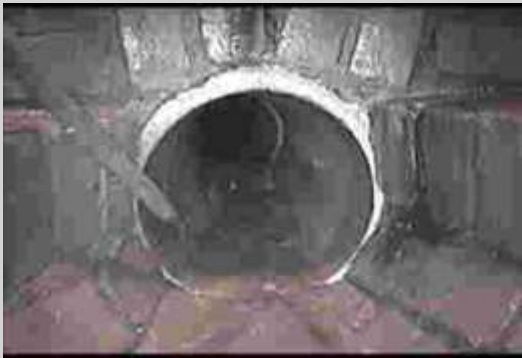
12 O'Clock Outflow

Pipe Height: **8.4** (in.) Rod and Bar (Angled)  
Pipe Material: **Clay** ☐ Pipe Lined  
Invert Depth: **11.02** (ft.) Flow Characteristics: **Fast**  
Deposits: ☒ None ☐ Mud ☐ Sludge ☐ Debris ☐ Grease  
Silt Depth: **0** (in.) Deposits Extent:  
Infiltration: **None** Pipe Seal Cond: **Sound**

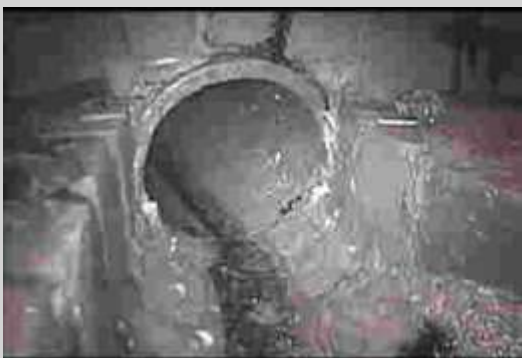
3 O'Clock Inflow

Pipe Height: **6** (in.) Rod and Bar (Angled)  
Pipe Material: **Clay** ☐ Pipe Lined  
Invert Depth: **10.46** (ft.) Flow Characteristics: **Slow**  
Deposits: ☒ None ☐ Mud ☐ Sludge ☐ Debris ☐ Grease  
Silt Depth: **0** (in.) Deposits Extent:  
Infiltration: **None** Pipe Seal Cond: **Sound**

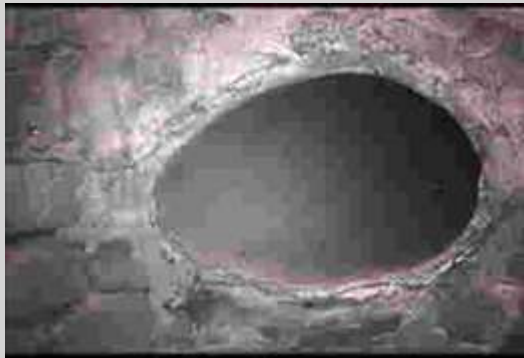
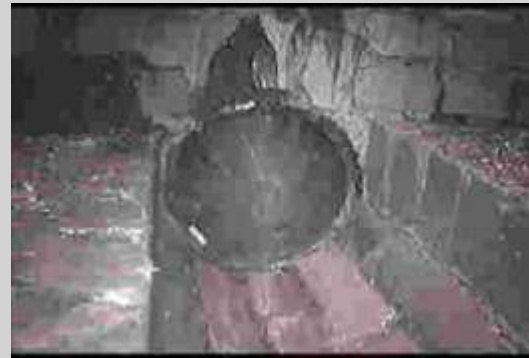
5 O'Clock Inflow

Drop: **Outside** Rod and Bar  
Angled: **Yes** Reading: **9.69** (ft.)  
Inv Depth: **10.69** (ft.)  
Drop Condition: **Open**

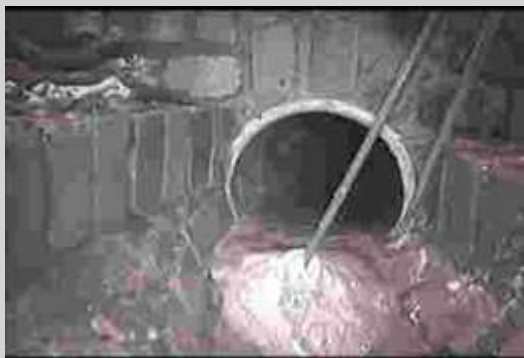
9 O'Clock Inflow

Deposits: ☐ None ☐ Mud ☒ ~~Sludge~~ ☒ **Debris** ☐ Grease

Silt Depth: **3** (in.) Deposits Extent: **Medium**
